Inspection Report

Mine Name: Marblehead Mtn (South Pit & Process Plant)

Operator Name: Chemical Lime Company of AZ

Inspection Date: March 25, 2008

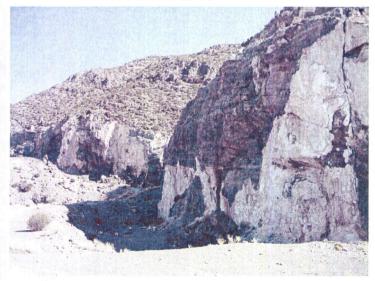
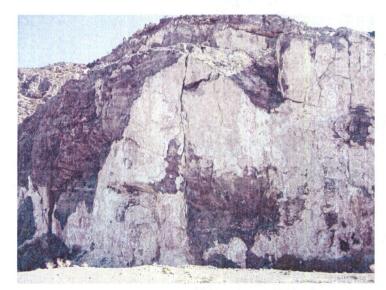
Photos taken 03-25-08

The quarry area appeared to have been in a state of inactivity for several years, with the exception that recreationalists (ATV's have been using the site extensively). While access is gated through the plant sight, there is unrestricted access to the South Marblehead pit that joins the quarry access road just below the quarry. There is highwall (both wedge failures and toppling rockfall) stability issues that should be addressed.

The access road between the plant and the quarry is showing eroding with small gullies developing. This needs to be corrected.

Access to the quarry area needs to be secured (blocked, gated, or ?) to prevent ATV access until the area is reclaimed. The access road between the plant and quarry needs to be maintained (or reclaimed along with the quarry area). If the plant is not going to be utilized in the near future, the operator should also consider reclaiming the plant site as well. The public safety is at risk related to some of the rockfall issues of the pit. Limiting access and rockfall devices (catchment berms, netting or?) should be addressed.
